Charles Flagg
School of Marine and Atmospheric Sciences, Stony Brook University

This is a quick update on the status of the breach prior to the nor'easter that's predicted for Friday and Saturday (Mar 2-3, 2018).

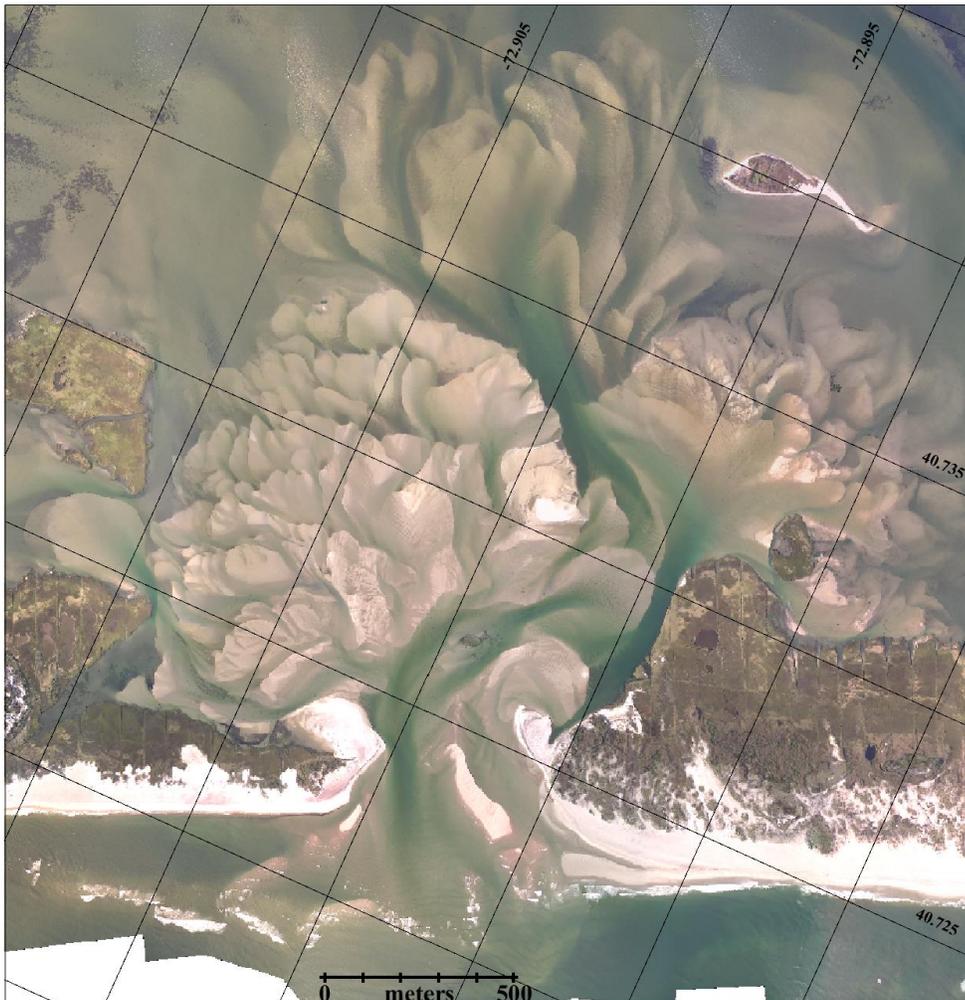
The fall of 2017 was pretty active in terms of windy weather, waves, flooding and changes in the breach. The waves from hurricane Jose in September knocked down many of the shoals in the breach which were then built up again over the next month. As a result, the October 20 overflight showed a re-establishment of the through-breach shoal with more sand for the shoal to the east of the remnants of Pelican Island.

The photo mosaic of the breach and flood and ebb deltas obtained on October 20, 2017.

October mosaic above with this latest version, notice that the through-breach sand island that showed up in July, has disappeared. The entrance channel into the breach is about 75m wide which a little smaller than it has been while the exit to the ocean continues to tail-off to the east.

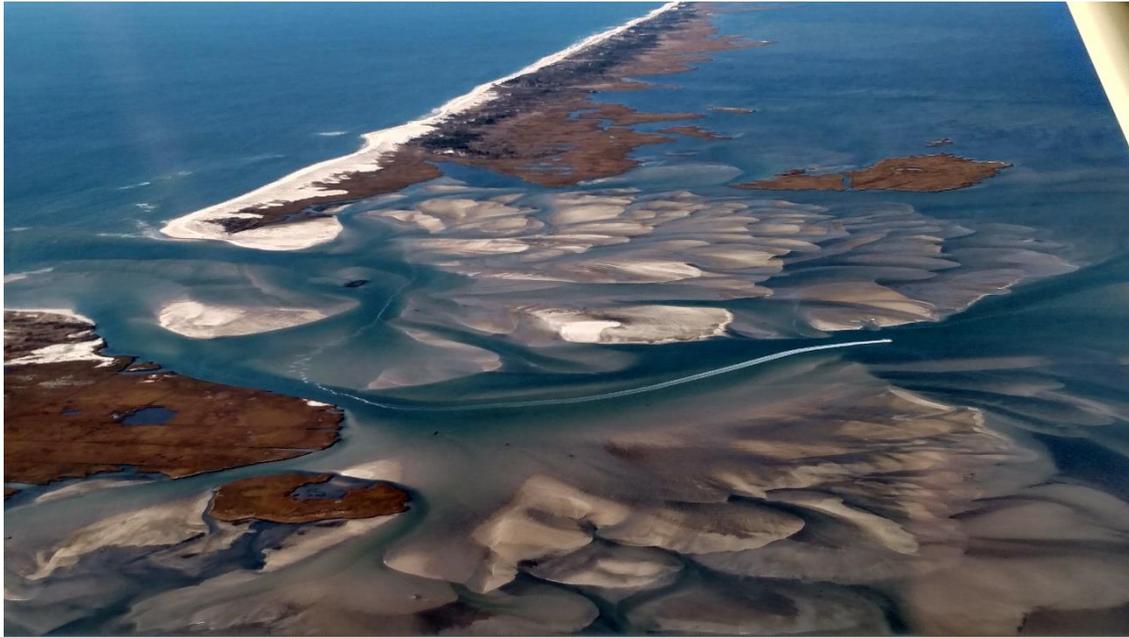
Oblique aerial photo of the breach and flood delta from the northeast on November 28, 2017.

The November 28 flight took place at 0930 EST, about 2 hours after low tide in the ocean and an hour before low tide in the Bay. As a result, many of the shoals of the flood delta were above water and easily visible in the oblique photo above. The track of the jet-ski visible in the photo shows that it followed the main channel and now goes north of the remains of Pelican Island, before heading off to the northwest. And the large shoal east of Pelican Island that has been building over several months, is now built up enough to be above water at low tide.

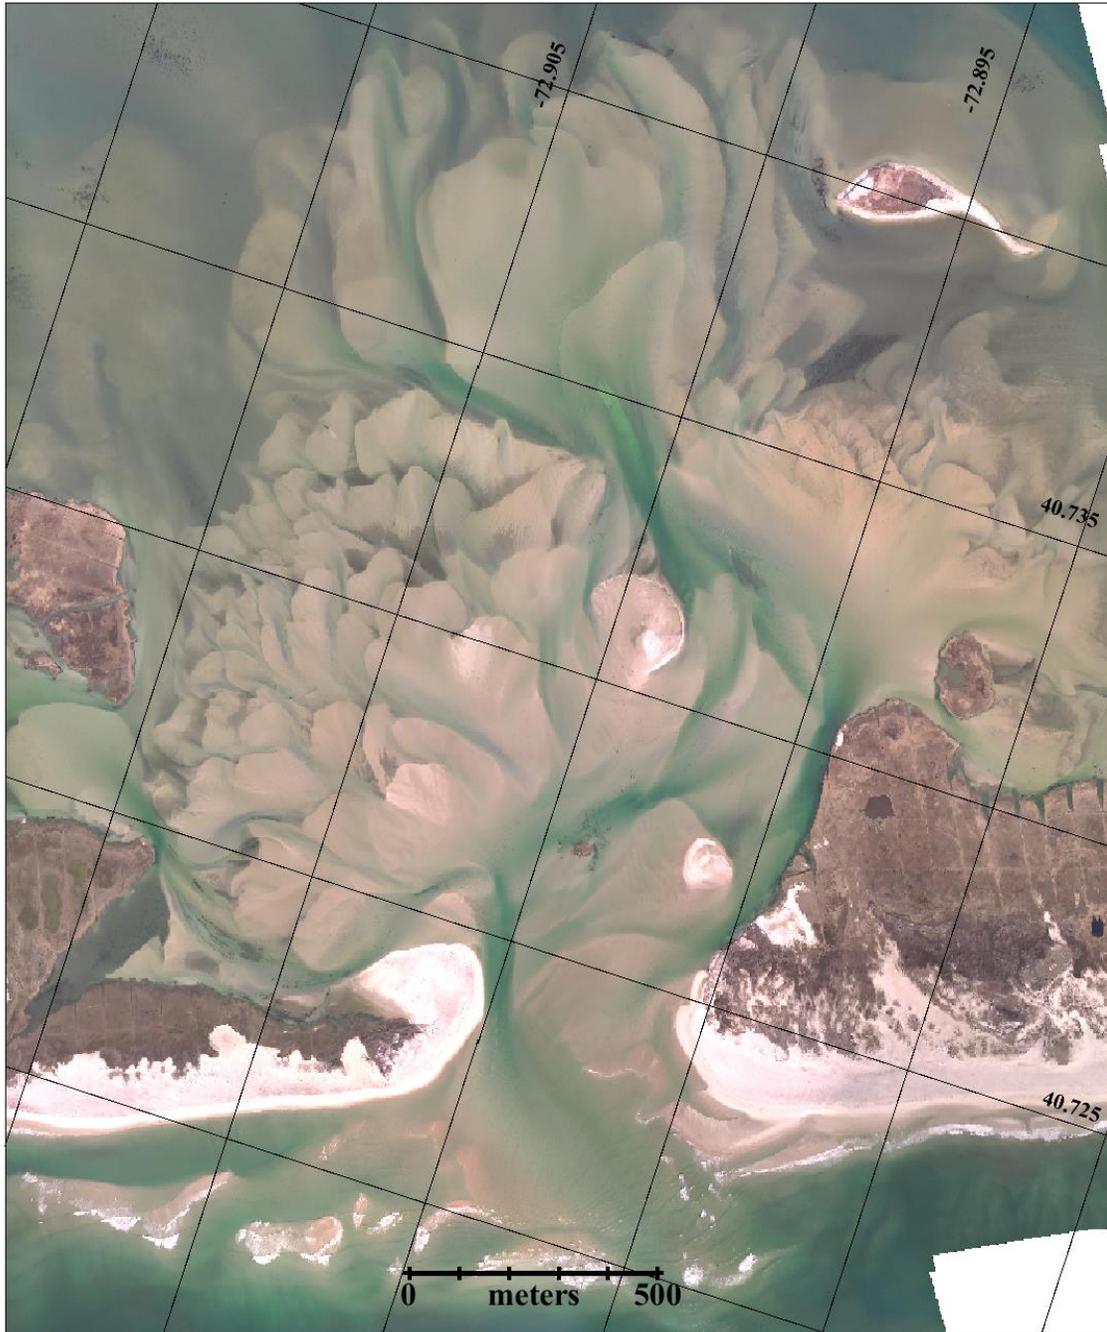
The breach looked very similar at the times of the January 27th and February 27th flights, both occurring during ebb and near low tide in the ocean. The figure below shows the latest mosaic from February showing the main features of the breach, flood and ebb deltas. The main message is that the channel through the breach has become more and more convoluted, a situation that has been building for the past year. This has led to the development of a sand island just north of the eastern shore in a location that was at one time the middle of the main channel. The channel into the Bay passes north of the Pelican Island remnants as it has for some time. In comparing the

Photo mosaic of the breach from the February 27, 2018 overflight at 09:15 EST.

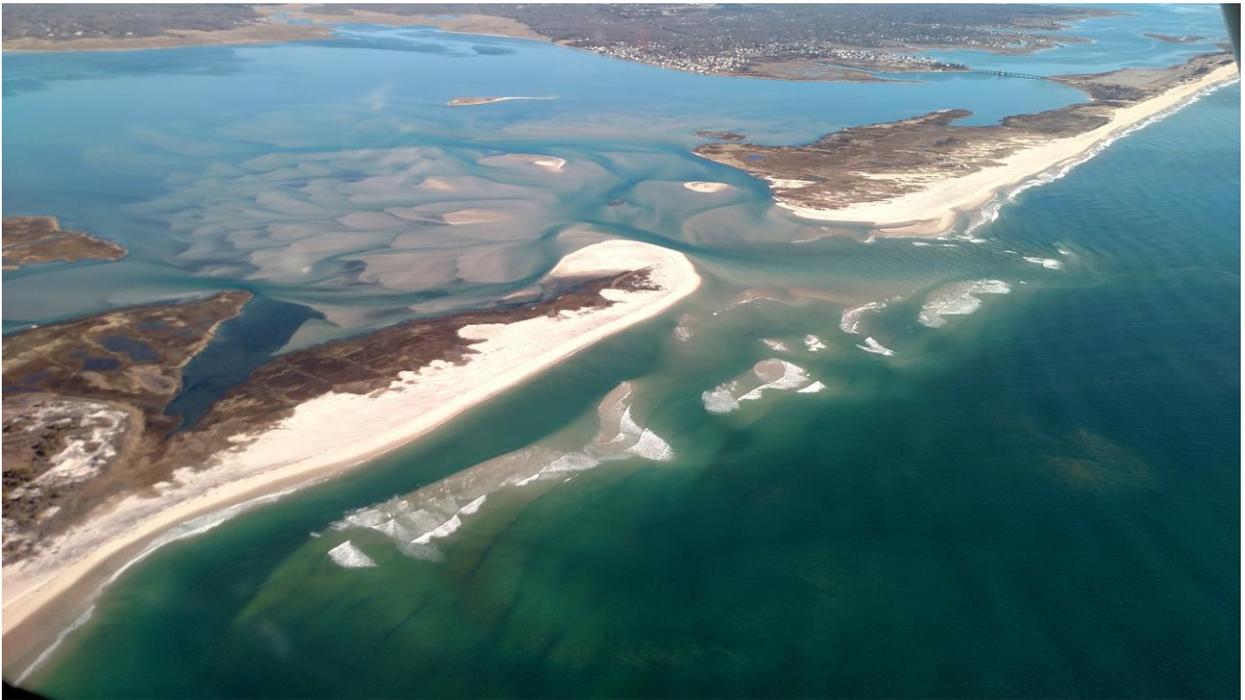
Another interesting thing is the development of the ebb shoal along the western shore. This has been going on for a long time but now there are several sand islands that are above water at low tide. The ebb shoal is formed by sand that has been exported from the breach. This sand can be thought of a sand that did not quite make through the breach and onto the flood delta. As

a result, the sand was expelled from the breach and settled out just off shore as the currents slowed. The alongshore channel just inside the sand islands of the ebb shoal is referred to as a “marginal bypass channel”. The bypass referring to the littoral drift of sand from the east that passes just offshore of the ebb shoal. The tail of the ebb shoal ends near the old inlet where there has been some erosion. The area farther west including that around Bellport Beach is outside of the immediate impact of the breach as for the most part, the littoral drift of sand from the east passes around the ebb shoal.

Oblique photo of the breach and western shore from the February 27, 2018 flight showing the elongation of the ebb shoal.
