Update on the Old Inlet Breach and Great South Bay

Charles N. Flagg, Roger Flood, Robert Wilson and Claudia Hinrichs
School of Marine and Atmospheric Sciences, Stony Brook University

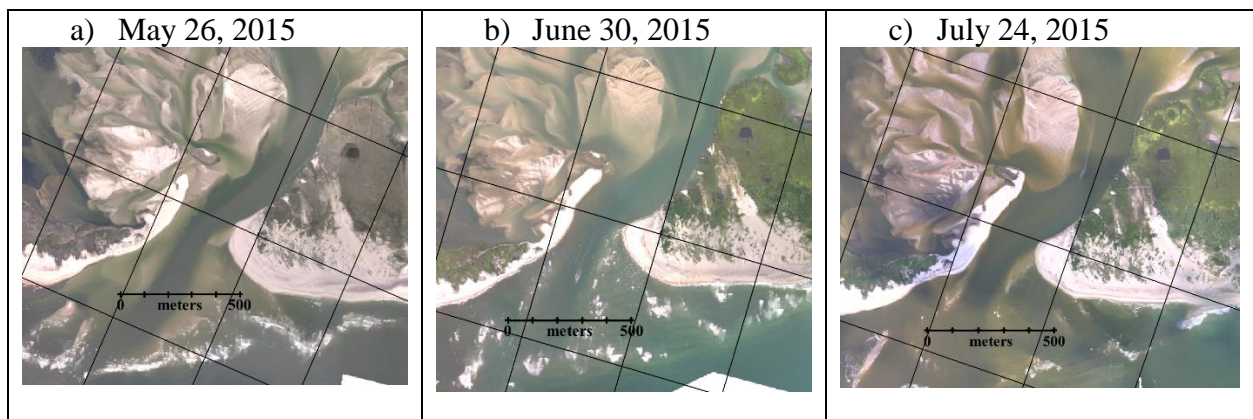
Figure 1, Photo mosaics of the Old Inlet Breach this spring showing the development of the western spit and the accretion of sand along the eastern shoreline. The scale at the bottom of each figure indicates 500 meters. Larger versions of these figures are available on the project website.

This year something different happened. Starting in May the spit started to grow as before but this year the eastern side also began to move out. And unlike in past summers, the spit kept growing until by the end of June the spit was within ~20 meters of Pelican Island. By mid-July, the spit had made contact with the island and by the end of July the spit had wrapped around the eastern side of Pelican Island and the previous connection to the western channel was completely cut off. This progression is shown in Figure 1 below.

The mosaics also show that the width of the breach opening has decreased over the past few months due to the extension of the spit but mostly as a result of the sand accretion along the eastern shoreline. The minimum width now is around 200 meters, substantially less than it has been in the past. Also of note are the along-channel shoals that have formed extending out to the outer ebb shoal. The shoal to the southwest is particularly prominent and is occasionally above water at low tide. These shoals form the edges of the main offshore channel reducing the width of the channel by roughly 50% compared to the distance between the east and west shores. This channel which started out nearly perpendicular to the original shoreline has since early 2014 run nearly north-south, some 15° clockwise from the large-scale Fire Island shoreline.

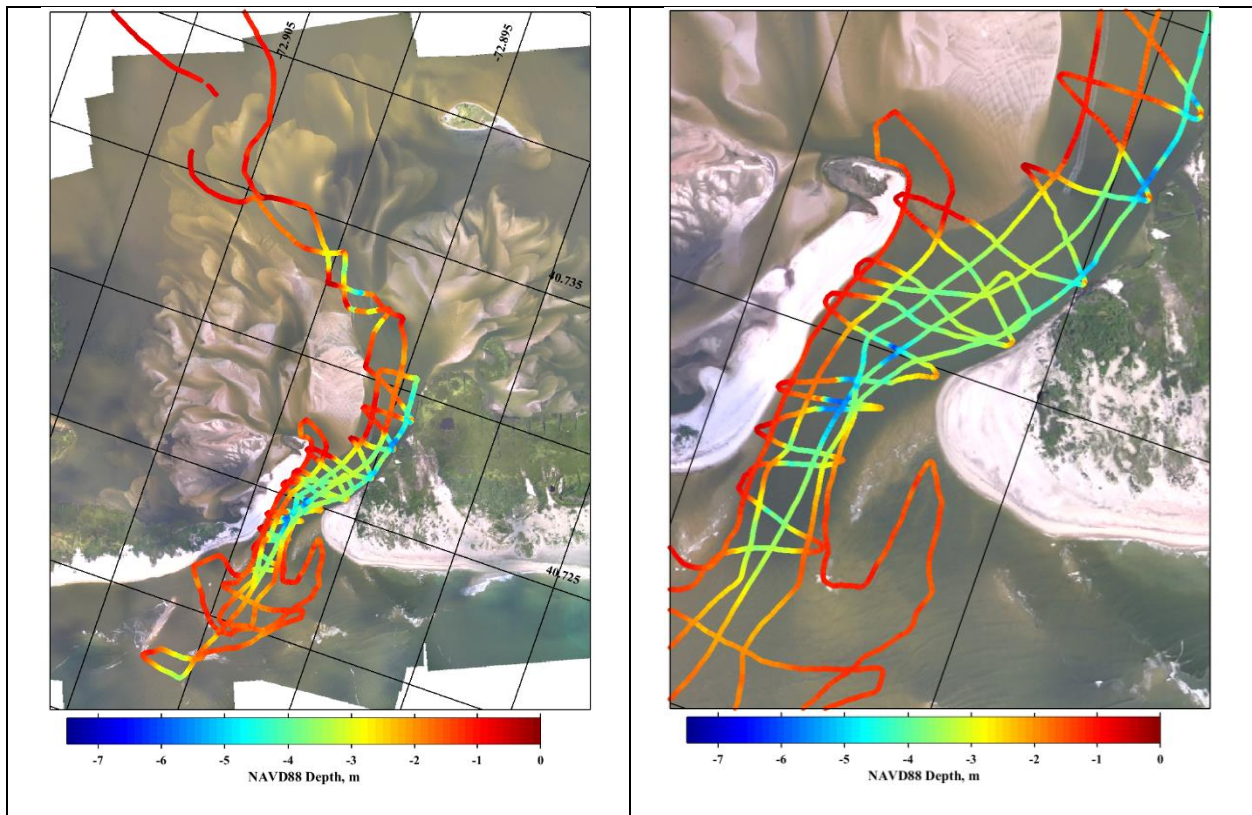
Figure 2. Track and depth plot of July 22, 2015 bathymetric survey on the July 24, 2015 aerial mosaic of the Old Inlet breach area. Depths are relative to the NAVD88 geoid.

On July 22nd we conducted a complete bathymetric survey of the breach and the approaches from the north. (Much of the flood delta is too shallow even for our small skiff and measurements in that area await permission from the Park Service to use a jet ski.) The entrance to the area is through a well-defined NW-SE channel with maximum depths of around 4 meters. The channel shoals and turns off to the northeast as one approaches Bellport Bay. In the area leading to the breach the main channel is along the north shore of Fire Island with depths approaching 5 meters. Within the breach itself, the maximum depth of about 6 meters is found farther south and west than previously in the narrowest part of the channel which is now formed by the shoal extending from the eastern shoreline visible in Figure 2, and the western shore.

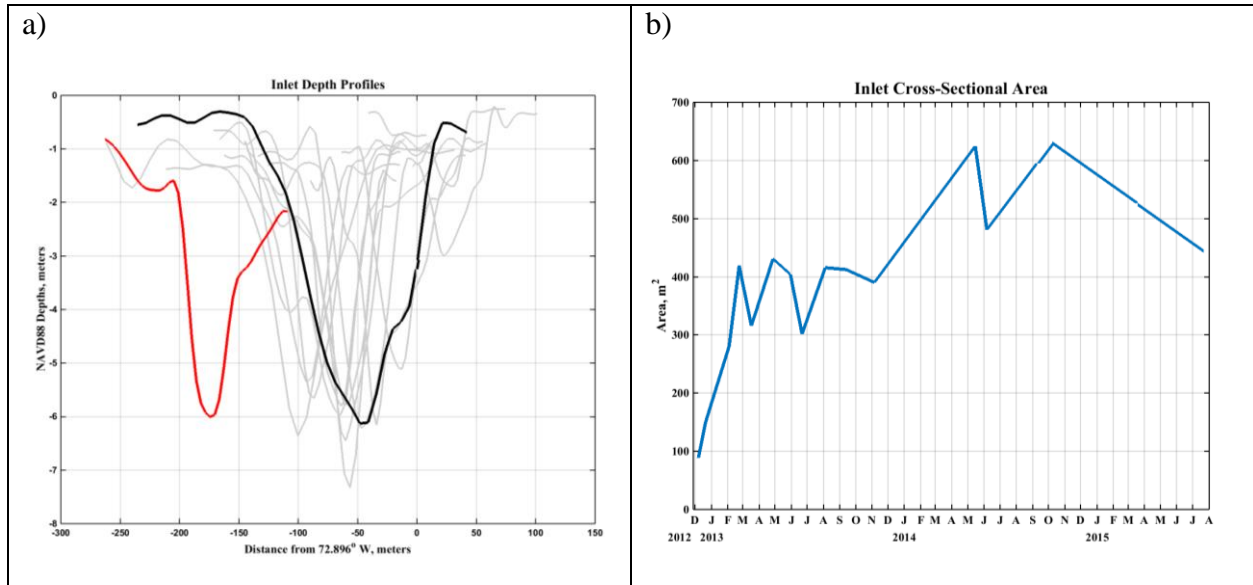
Figure 3. a) Cross-section profiles of the breach from the 15 bathymetric surveys. The October 2014 profile is shown in black, the July 2015 profile is shown in red where the change in cross-sectional areas is clearly visible. b) Time series plot of the minimum cross-sectional areas for each of the surveys.

The other notable observation about the changes in the channel is that the cross-sectional area has decreased compared to our measurements in 2014 as shown in Figure 3. During the first

year after the formation of the breach the minimum cross-sectional areas quickly ramped up to between 300 and 400 m², shown in Figure 3b. The number of surveys decreased in 2014 but those we did do suggested that the cross-sectional areas had increased by 50% to 500 to 600 m². This increase coincided with disappearance of the Old Inlet dock and the development of the NE-SW channel to the Bay. This latest survey on July 22nd suggests that the minimum cross-sectional area has decreased to roughly 450 m². The narrowing of the channel is quite evident in the profiles shown in Figure 3a. Since we do not have any recent velocity measurements it is unclear whether this decrease in cross-sectional area has led to a decrease in the ocean-Bay tidal exchange.

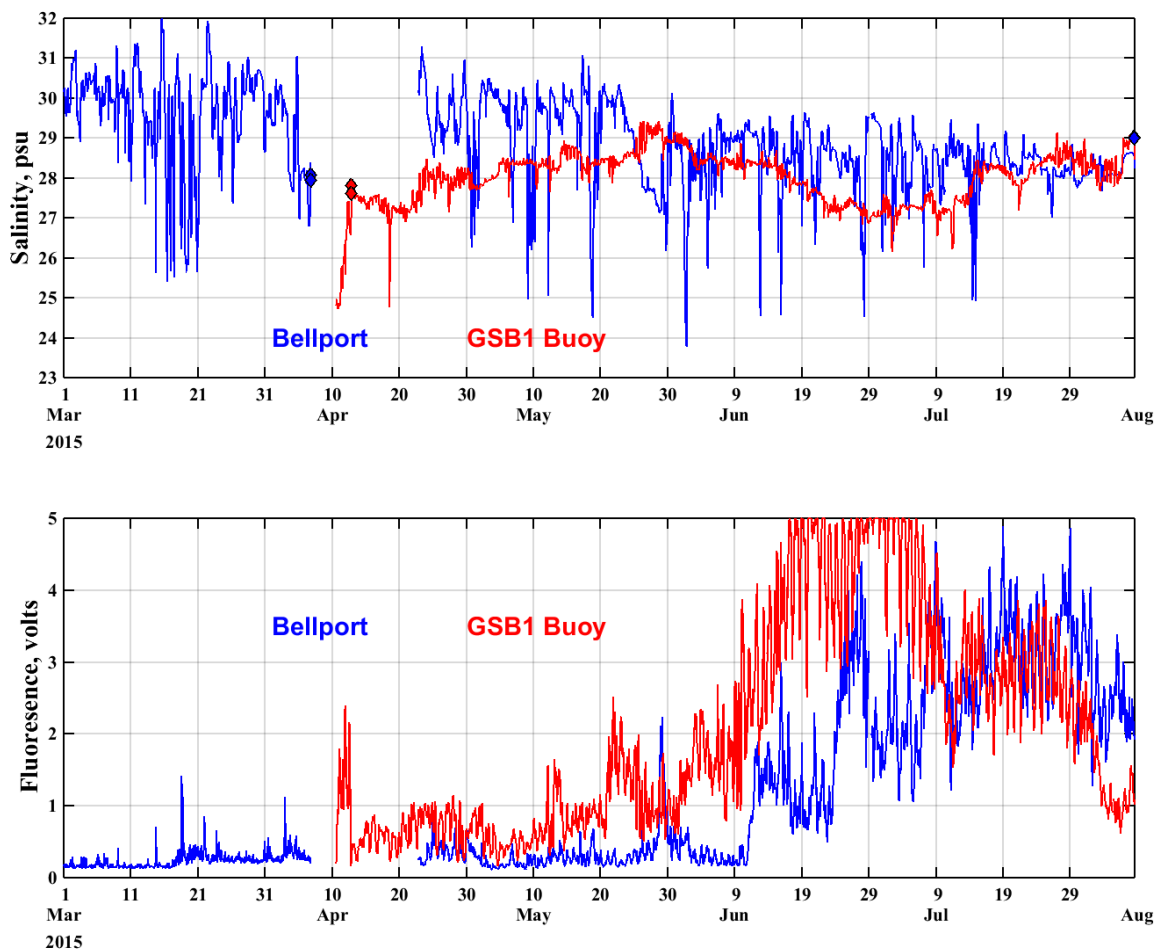
Figure 4. Time series of salinity, upper panel, and chlorophyll fluorescence, lower panel, from Bellport and the GSB1 buoy. Salinity calibration samples in April and August are shown as solid diamonds.

The other aspect of the Great South Bay project is to keep track of what is happening to the water properties of the Bay. Salinity is the best indicator of mixing between ocean, Bay and fresh water sources; whereas fluorescence gives us an indication of biological activity. Both these parameters at the Bellport dock and GSB1 buoy south of West Sayville are plotted in Figure 4 for the period March 1st through August 5, 2015. Salinities at Bellport were around 30 psu during the late winter and spring with substantial variations during periods of fresh water outflow from the creeks. Then in late May/early June salinity at Bellport dropped noticeably to less than 29 practical salinity units (psu) and has tapered off to around 28 psu by the end of July. By the end of the record the salinities at Bellport are essentially the same as those record at the GSB1 buoy, something that has not happened since after a huge rain storm in June of 2013. These lower salinities are not unusual at Bellport but not for this extended a period and not without a large rain storm. It is tempting to ascribe these salinity changes to the changes we have seen in the breach bathymetry. Presumably, a smaller opening to the ocean should reduce the ocean Bay exchange. However, throughout 2013 the breach had cross-sectional areas similar to or smaller than the recent survey with much higher salinities, 30 to 31 psu, than we are seeing now. So exactly what is going on to change the salinity over the last couple of months and whether this trend will continue is unclear at this point.

The lower panel in Figure 4 shows the record of chlorophyll fluorescence during this spring/early summer period. This instrument works by flashing a high intensity light at a small volume of water which causes the chlorophyll molecules to flash back, or fluoresce, at a different wavelength. The intensity of the return flash is proportional to amount of chlorophyll, hence algae, in the water. The records show that at Bellport there was very little plant matter in the water until the second week of June at which point the brown tide bloom started in Bellport Bay. This bloom was delayed at Bellport by nearly a month relative to the waters to the west where the bloom got quite intense by mid-June. By the beginning of July the bloom over the western portions began to dissipate but remained significant in Bellport Bay. And by the end of July the bloom seemed to be largely over in the west. On a purely qualitative basis, on July 7th the waters in Bellport Bay had a definite greenish color while those in Patchogue Bay remained brown. The fluorometer does not distinguish between the myriad algae species in the Bay so it is quite possible that we are seeing a different algal succession in Bellport Bay relative to that in Patchogue Bay and farther west. As noted above, the salinity in Bellport Bay is less than it has been in recent spring/summer periods suggesting a reduced ocean/Bay exchange resulting in high nutrient levels. In this way, the lower salinities might be related to the recent strength of the brown tide bloom in Bellport Bay.
